**DOT/FAA/TC-17/18**

# **Effects of Repair Procedures on Bonded Repairs of Airframe Structures**

November 2017

Final Report

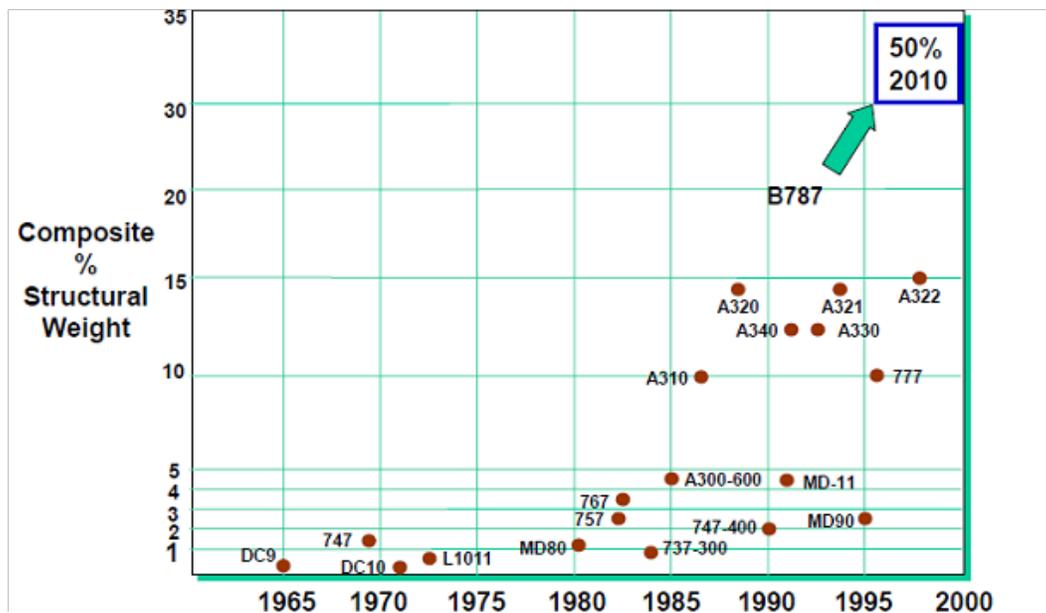
Figure 1. Composites in commercial transport aircraft [1]

Numerous general aviation airframes are using composite materials, including the Cirrus SR22, the Bombardier's new C-Series family (20% composite), the Mitsubishi's new regional jet, and Bombardier's Learjet 85 [1]. Similarly, the use of composite materials in military applications started with the U.S. Navy F-14 and the U.S. Airforce F-15 fighters and has steadily increased with the F-18, the F-22 (at least 33% composites), the B2 stealth bomber, and the V-22 (50% composite weight percent). Figure 1 shows the increased composite structural weight percent in commercial airframes in the last four decades.

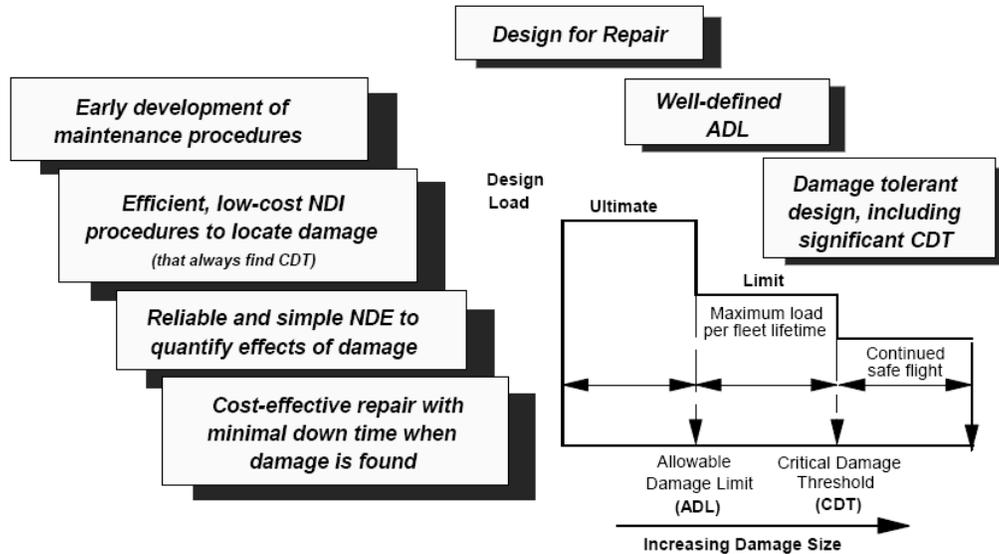
**Figure 2. Design load and damage considerations for durability and design [5]**

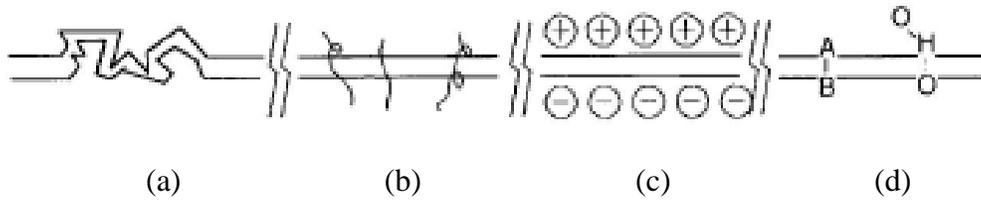
**Figure 3. Contribution to adhesion: (a) mechanical interlocking, (b) interdiffusion of chains, (c) electrical interactions, and (d) chemical interactions [20]**

Epoxy resins are thermosetting polymers widely used in structural adhesives and matrix resins for composites, but they can also be used as surface coatings. Cross linking occurs primarily by the reaction of epoxide groups, molecules containing a three-membered ring consisting of one oxygen atom and two carbon atoms. Four mechanisms, involving both physical and chemical interactions working alone or together are used to describe the theory of adhesion: mechanical interlocking, interdiffusion, electrostatic attractions, and chemical interactions, with the last being the most widely accepted [20]. Interdiffusion of long-chain molecules occurs when two polymers are placed in close contact at temperatures above their glass transition temperature ( $T_g$ ) and depends on the degree of compatibility of the polymers. Chemical interactions between two bodies involve the contribution of different intermolecular and interatomic forces: van der waal forces and the formation of true chemical bonds, mainly ionic, covalent, or hydrogen bonds (shown in figure 3).

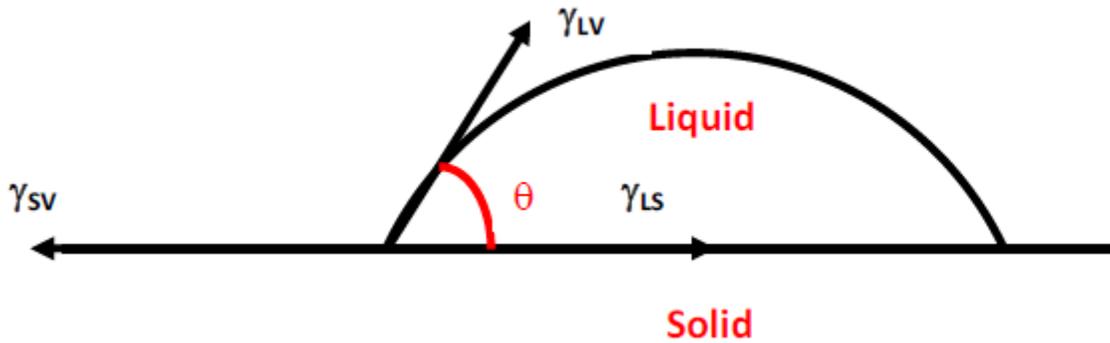
**Figure 4. Contact angle between the liquid and solid surface**

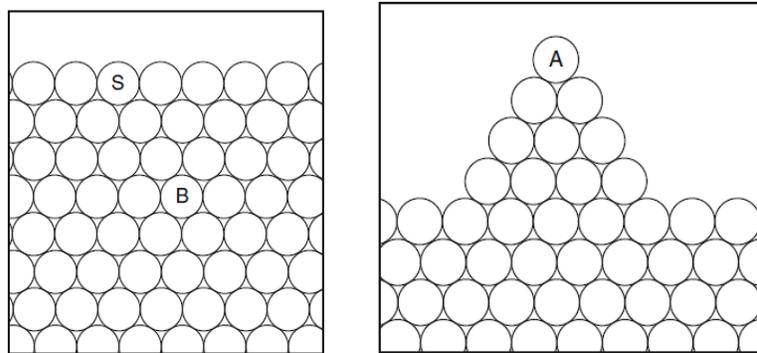
**Figure 5. Local environment of an atom in the bulk of a material, on a plane surface, and on a rough surface**

In figure 5, *SV*, *LV*, and *SL* refer to the solid/vapor, liquid/vapor surfaces, and the solid/liquid interface, respectively.

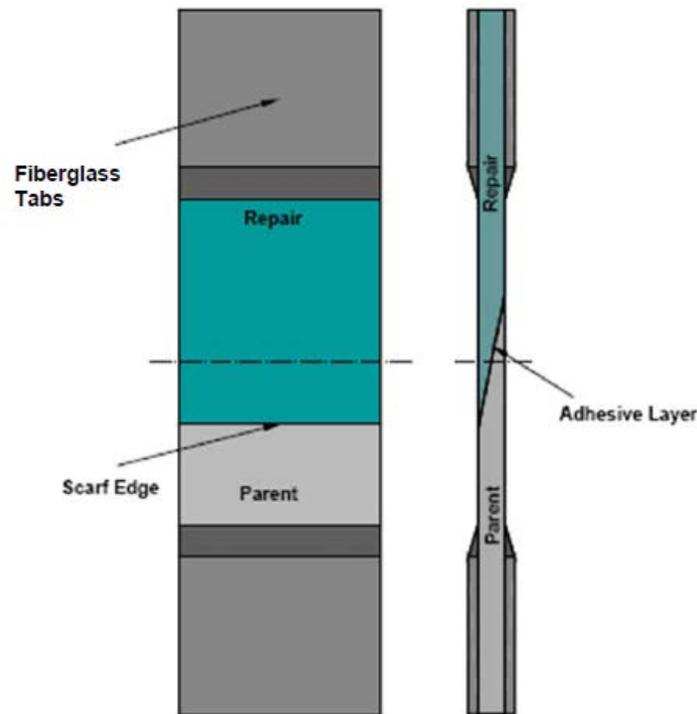
**Figure 6. Repair coupon configuration**

Baseline repair data were generated for repair systems that were representative of factory and field repairs. The factory repairs were used as a baseline for the damage tolerance investigation, whereas the field repairs were used as a baseline for the contamination investigation. Variables considered included different substrate moduli, repair materials, scarf ratios, laminate thicknesses, and environmental conditions. The coupon configuration chosen for the study was a 4-inch-wide single scarf joint, as shown in figure 6.

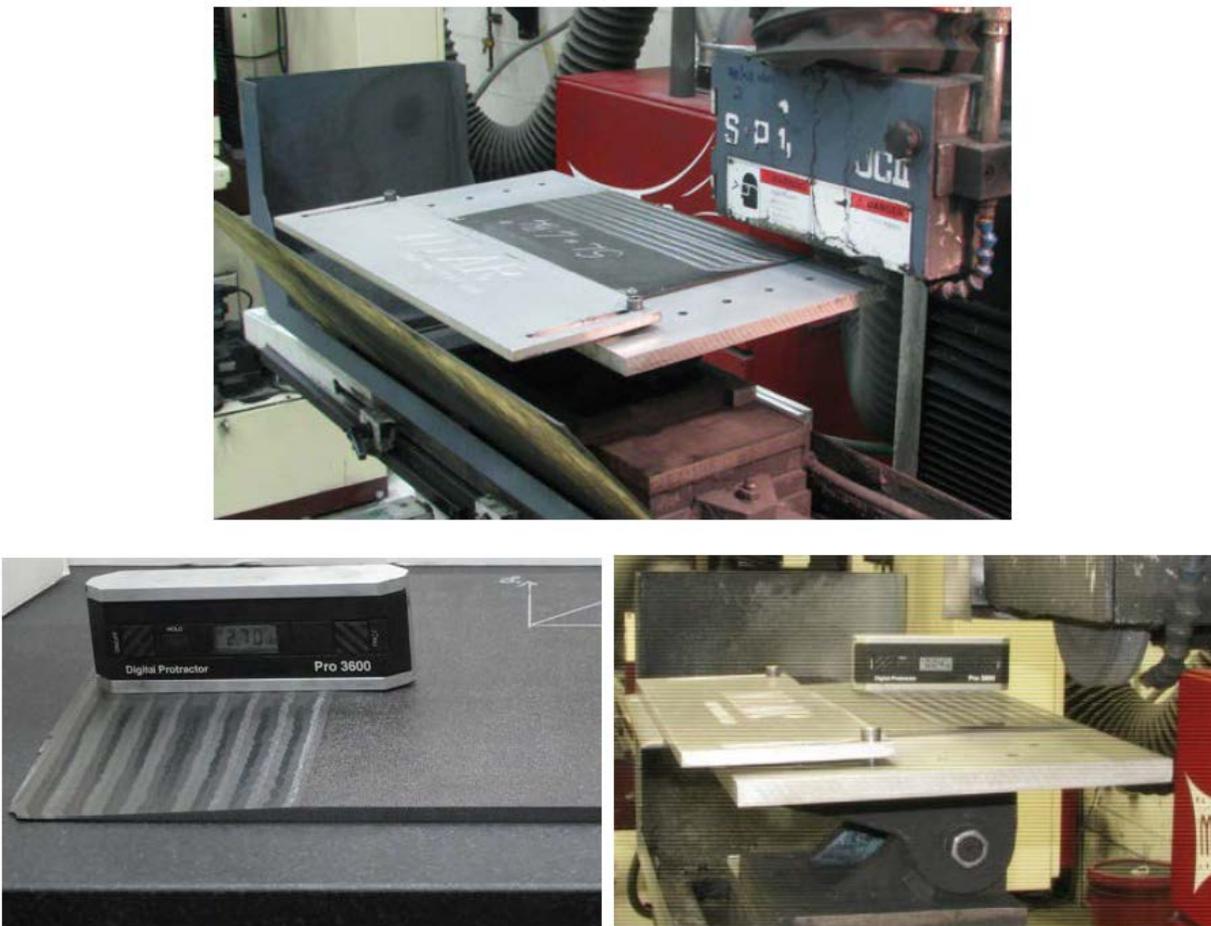
**Figure 7. Repair coupon scarf grinding setup**

Panels of different thicknesses and substrate moduli were manufactured by the OEM. All parent panels were cured in an autoclave at 350°F at 85 psi. After fabrication, the test panels were inspected using through-transmission ultrasonics (TTU) and pulse echo equipment according to OEM procedures to ensure the manufacturing integrity of the panels and to detect any flaws induced during fabrication. An aluminum oxide grinding wheel with a fixture set to the target scarf angle was used for machining the coupons, as shown in figure 7. All grinding was

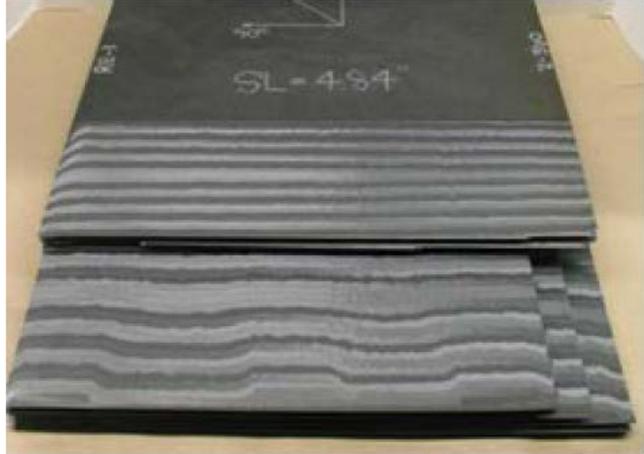
**Figure 8. Machined/scarfed subpanels ready for repair**

conducted using a coolant to avoid ply delamination and to ensure proper dust collection. The scarfed surface prepared for bonding was solvent wiping using acetone. Figure 8 shows scarfed panels ready for repair.

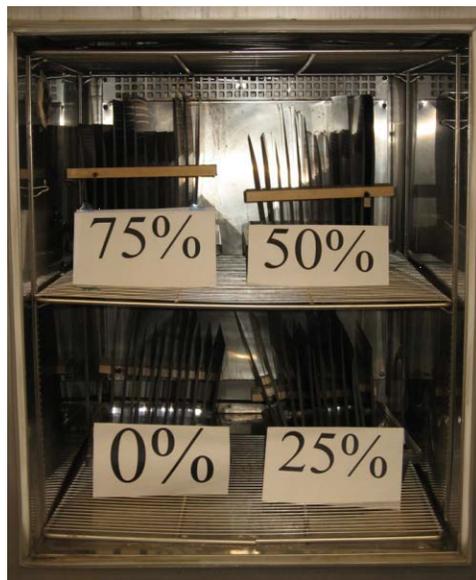
**Figure 9. Water (moisture conditioning) exposure**

Five different contaminants were used for the contamination investigation: (1) JF (JP-8, MIL-T-83133), (2) PS (Methylene Chloride ASTM D4701), (3) Skydrol (SH) (Skydrol LD-4), (4) water, and (5) perspiration (PR). The JF and SH panels were soaked in the contaminants for 30 days, PR (34g/L salt water ASTM D1141 equivalent) was applied to the surface prior to bonding, PS panels were exposed to the contaminant for 6 days, and water panels were exposed to moisture at 85%RH at a temperature of 180°F until moisture equilibrium was achieved. Once 100% moisture equilibrium was achieved (referred to as 100% saturation), panels were subsequently dried to achieve %saturation levels of 75%, 50%, and 25%. Figures 9 and 10 show examples of the contamination procedure for water- and SH-contaminated panels, respectively.

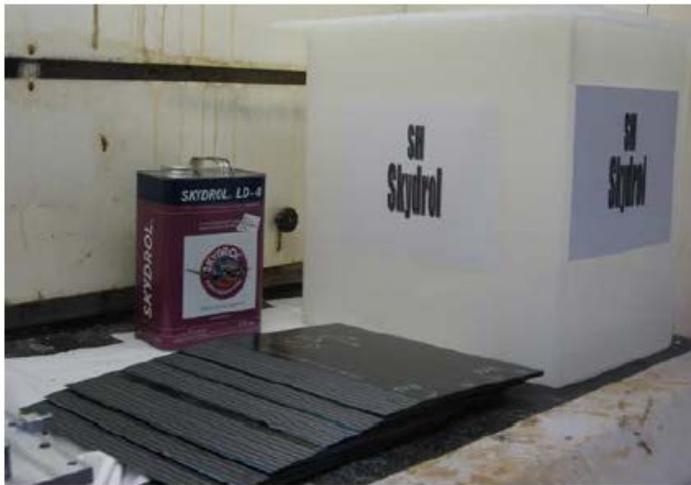
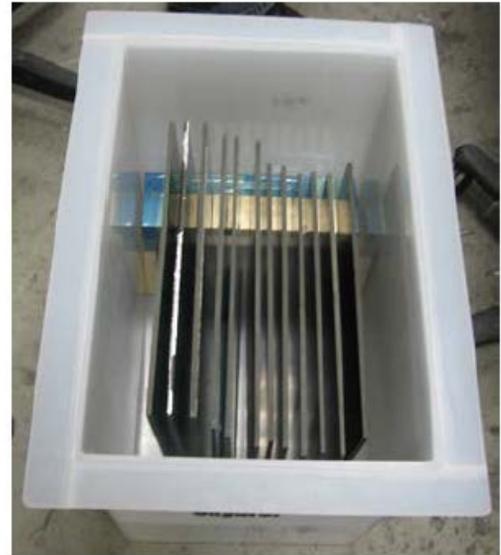
**Figure 10. SH exposure**

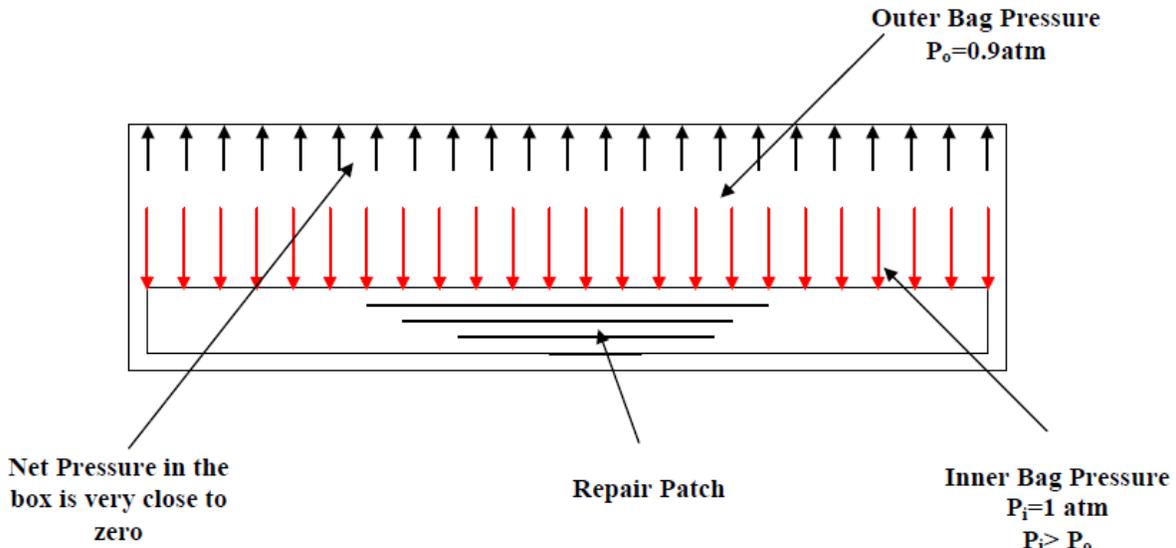
**Figure 11. DVD process diagram**

All coupons used for the damage tolerance investigation were repaired using the double vacuum debulking (DVD) process. The DVD process was used to consolidate the repair patch prior to bonding it to the cured scarfed parent. Repair plies were assembled so that the repair ply matched the orientation of the parent laminate. The main advantage of the DVD process was that the B-staged, partially cured patch could be cured under vacuum without the use of pressure. The repair patch consolidation was prepared as shown in figure 11. The purpose of the outer bag over the flexible inner bag was to relieve the clamping pressure on the patch caused by the inner bag. The vacuum level in the two chambers could be operated independently. Because the outer chamber was rigid, the net effect on the two vacuum chambers was that no pressure was applied over the patch area, allowing trapped air and volatiles to diffuse out as the resin viscosity decreased. The outer vacuum was then vented to allow full compaction by the inner bag. This method has been shown by the U.S. Navy to produce low porosity patches as compared to a typical single bag [32 and 33].

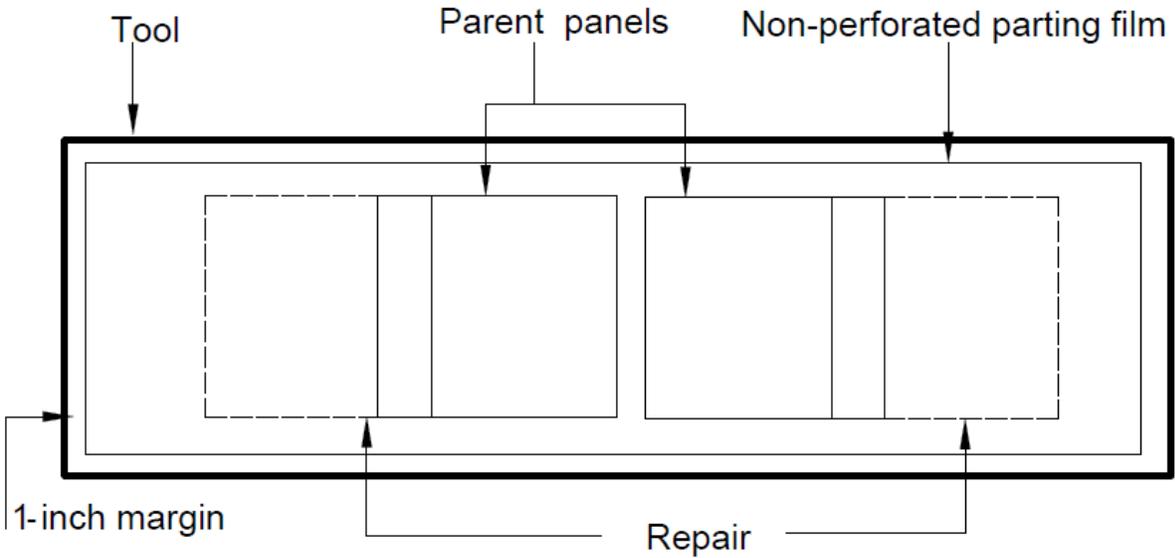
**Figure 12. Scarfed panels cleaned and placed on the repair tool prior to bonding**

A sheet of non-perforated separator film was secured to the tool using tape. The separator film was secured so that it extended beyond the footprint of the parent panel and the repair, as shown in figure 12. A 1-inch margin was left on each side of the tool near the edge for sealant tape application. The parent panels were then placed on the tool (figure 12) and secured with tape (flashbreaker 1R) to prevent the panels from moving during repair. The panels were then cleaned using acetone applied to a lint-free cloth. It should be noted that the solvent should never be sprayed directly onto the surface, but onto the cloth first and then the wet (solvent) cloth should be used subsequently to clean the surface.

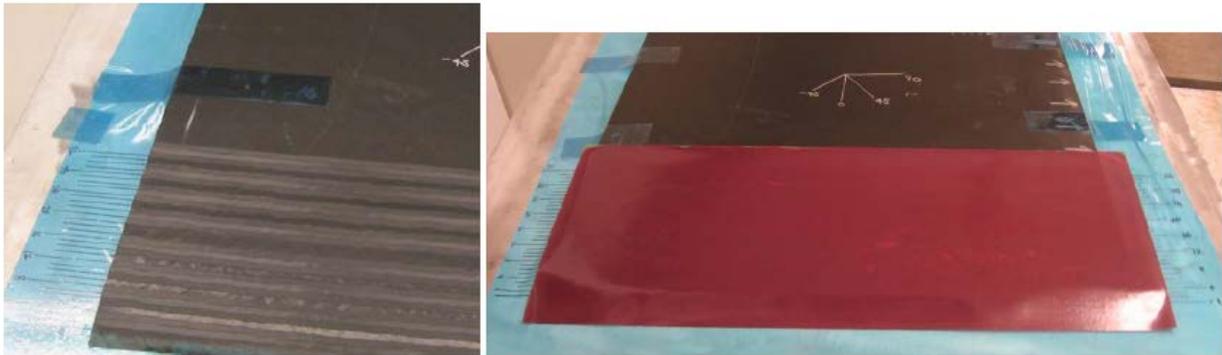
**Figure 13. Ply location markings/adhesive application prior to repair ply application**

Using a black Sharpie® marker, the lines of all plies were extended from the scarf onto the parting film for a length of one inch on both sides of the panel, as shown in figure 13. These markings were used to align the repair plies during the lay-up. The repair kits were taken out of the freezer at least 12 hours prior to use and allowed to reach room temperature prior to repair. Kits were labeled according to the corresponding parent panel identification.

The adhesive backing film was then removed and the adhesive applied onto the scarf region, as shown in figure 13. The repair plies were then carefully aligned using the extended scarf lines previously drawn and laid up following the parent stacking sequence as specified in the repair lay-up sheet, as shown in figures 14 and 15.

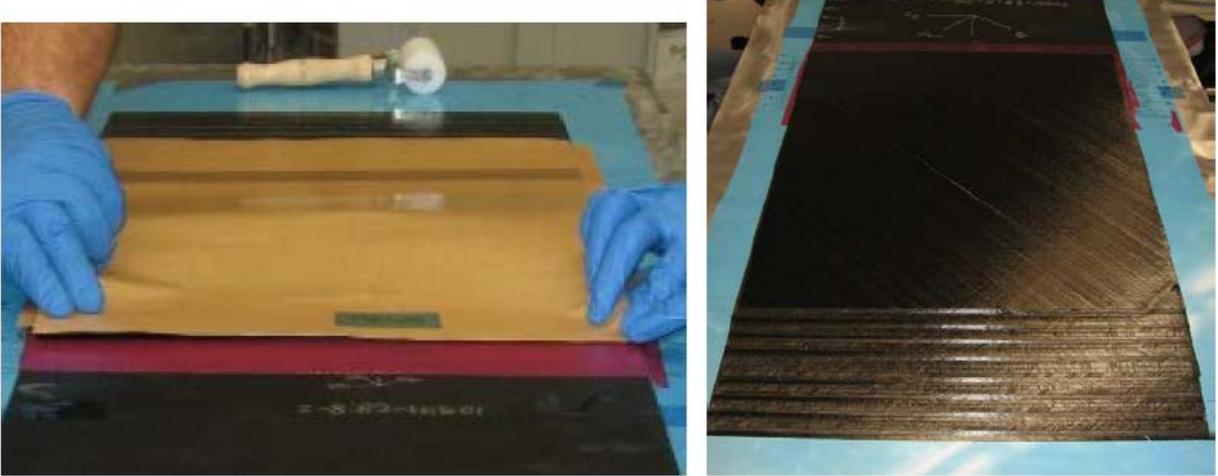
**Figure 14. Individual repair ply lay-up procedure**

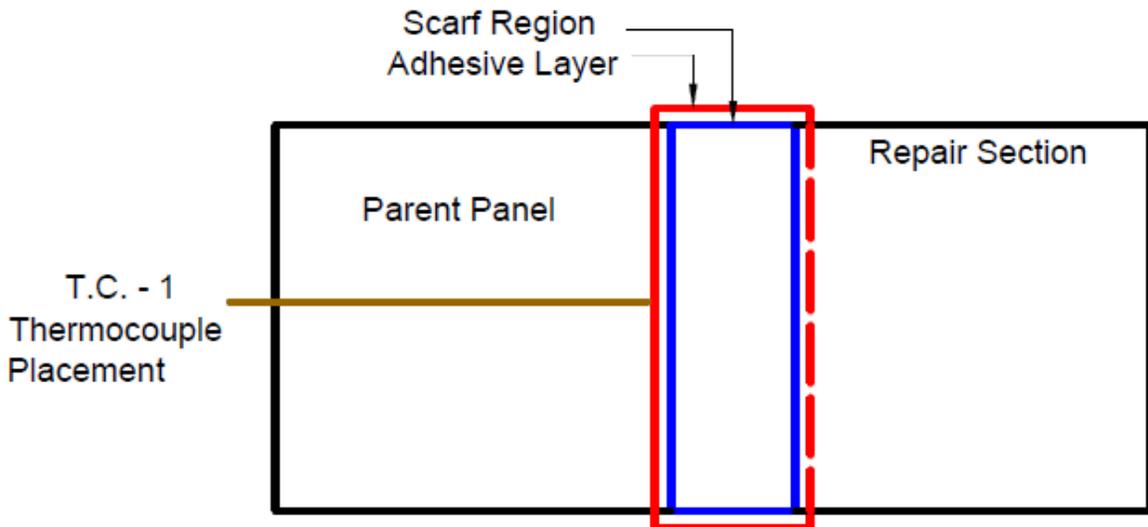
**Figure 15. Thermocouple placement**

One thermocouple was placed on each repair panel, secured to the tool using tape, and labeled according to figure 15.

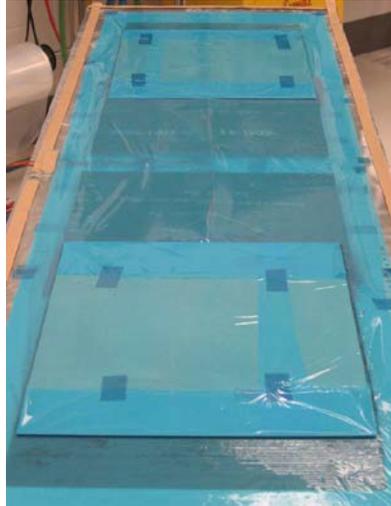
**Figure 16. Caul sheet placement/repair panels ready for bagging**

A layer of separator film was placed over the repaired panels and secured with approved tape. Caul plates were placed on the repair panels, as shown in figure 16. The assembly was then bagged, as shown in figure 17, to ensure that no wrinkles were apparent on the bag around the vacuum port or on the repair and that there was no evidence of pinching/squeezing at the edge of the laminates. A vacuum leak was then performed to ensure that the maximum vacuum loss did not exceed 2" Hg in 5 minutes.

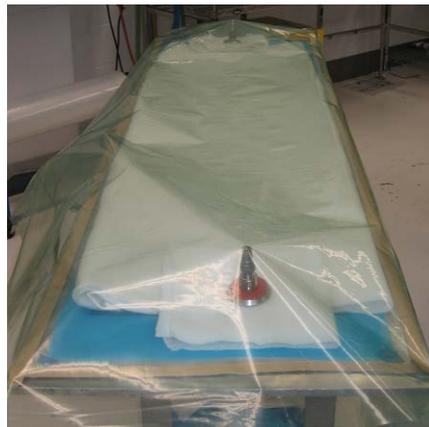
**Figure 17. Repair panel bagging procedure**

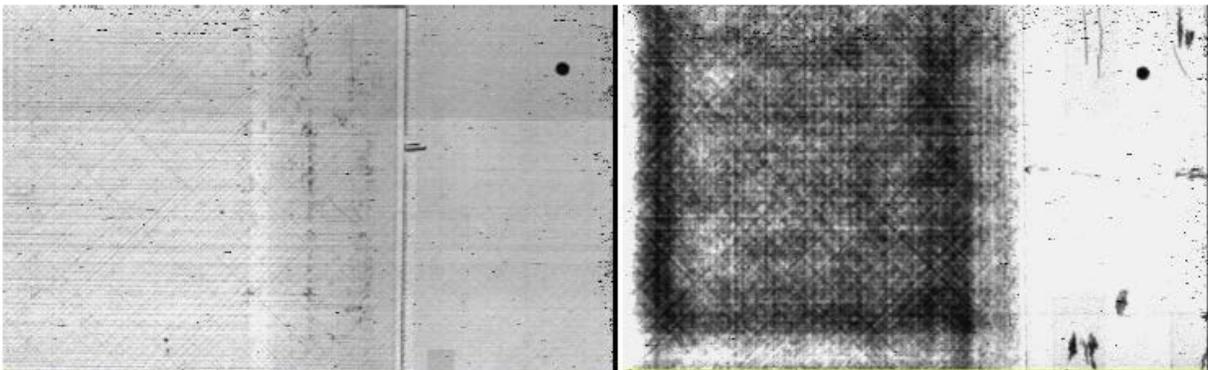
**Figure 18. Representative c-scans of panels contaminated with JF prior to repair**

NDI using TTU was conducted on the repaired panels and showed variability in the repaired laminates with the porosity/consolidation levels, as shown in figures 18–22.

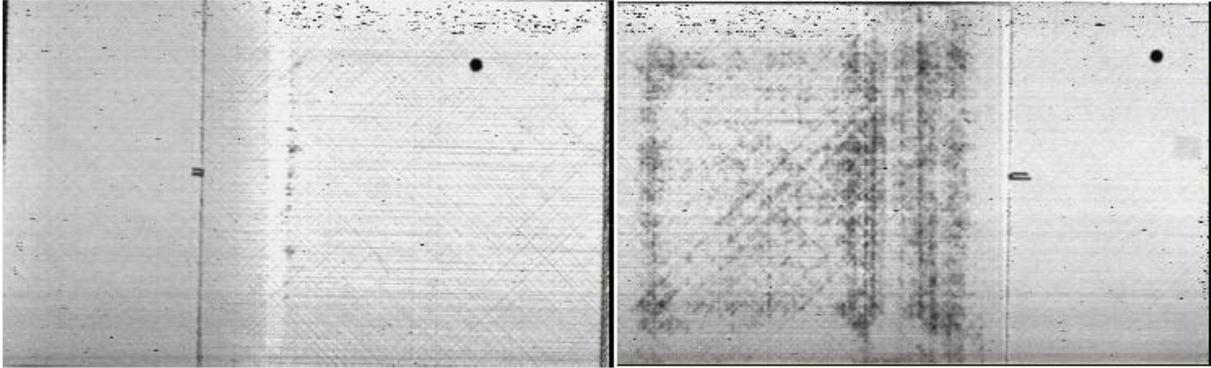
**Figure 19. Representative c-scans of panels exposed to PR prior to repair**

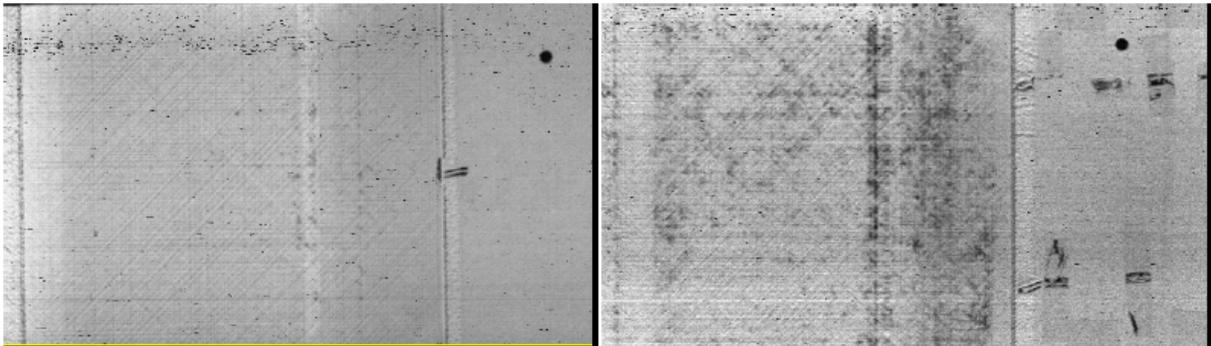
**Figure 20. Representative c-scans of panels exposed to PS (methylene chloride) prior to repair**

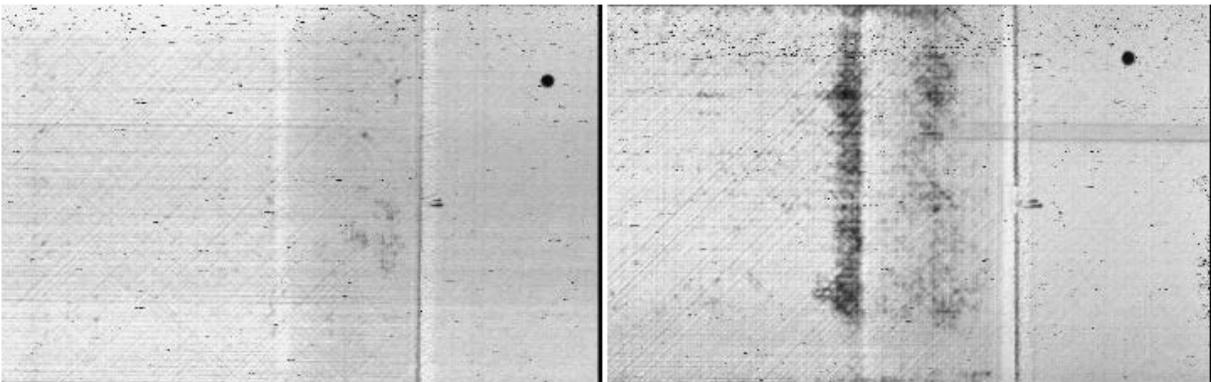
**Figure 21. Representative c-scans of panels exposed to SH prior to repair**

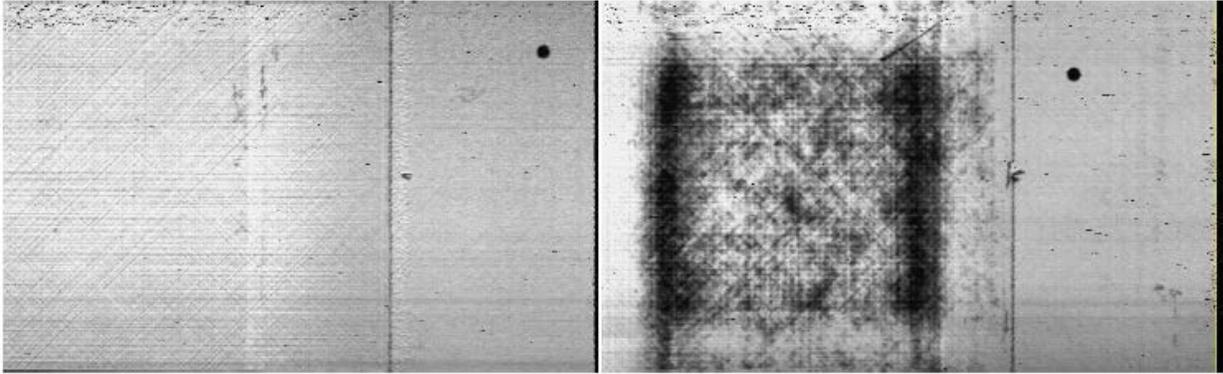
**Figure 22. Representative c-scans of panels exposed to water prior to repair**

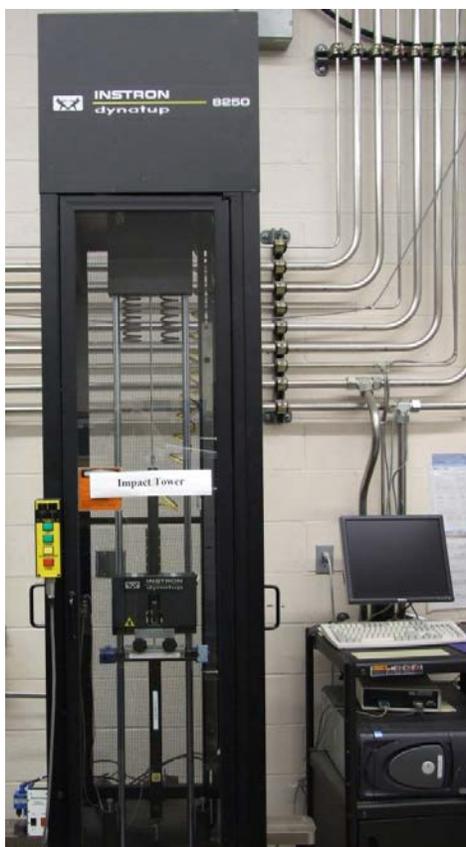
**Figure 23. Instron Dynatup**

An Instron<sup>®</sup> Dynatup<sup>®</sup> 8250 Drop Weight Impact Tester, configured with a 5000-lb piezoelectric load cell and a 1.2" diameter impactor, was used to inflict the damage on the repair coupons, as shown in figure 23. The test machine consisted of a frame, two guide columns, a hoist motor, a drop weight mechanism, a control pendant, and accessories. The machine can be operated in gravity-assisted or pneumatic mode. In gravity-assisted mode, the maximum velocity that can be achieved is 12.7 ft/sec, whereas in pneumatic modes, velocities up to 44 ft/sec can be achieved. The test machine has variable impactor weights: 5.5, 10, 25, 50, 75 and 100 lbs, as well as variable impactor end geometries and a maximum drop height of 46" to accommodate different specimen tup selections and specimen thicknesses. In gravity-assisted mode, a maximum impact energy of 223 ft-lb can be achieved, whereas in pneumatic mode, a maximum impact energy of 326 ft-lb can be achieved.

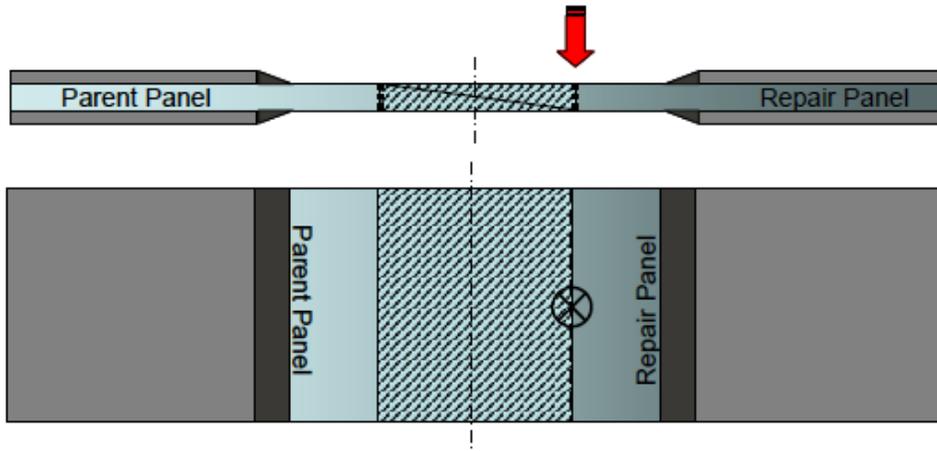
**Figure 24. Damage site for the impact specimens TF (tip far)**

All 18-ply and 48-ply repair specimens were impacted at different locations in the repair scarf region, as shown in figures 24–26. Three different impact sites were considered: (1) at the tip of the scarf from the far side (TF), (2) at the tip of the scarf from the near side (TN), and (3) at the scarf center (CN). The intent was to investigate the potential differences in residual strength resulting from different impact sites.

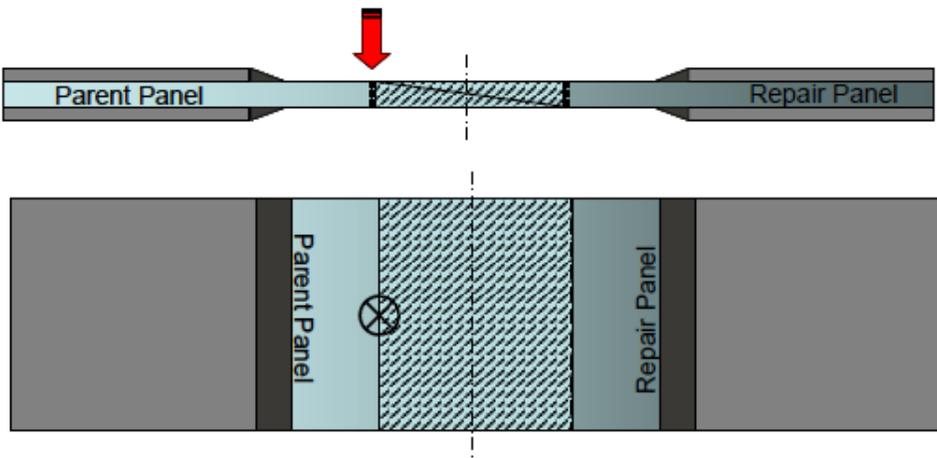
**Figure 25. Damage site for the impact specimens TN (tip near)**

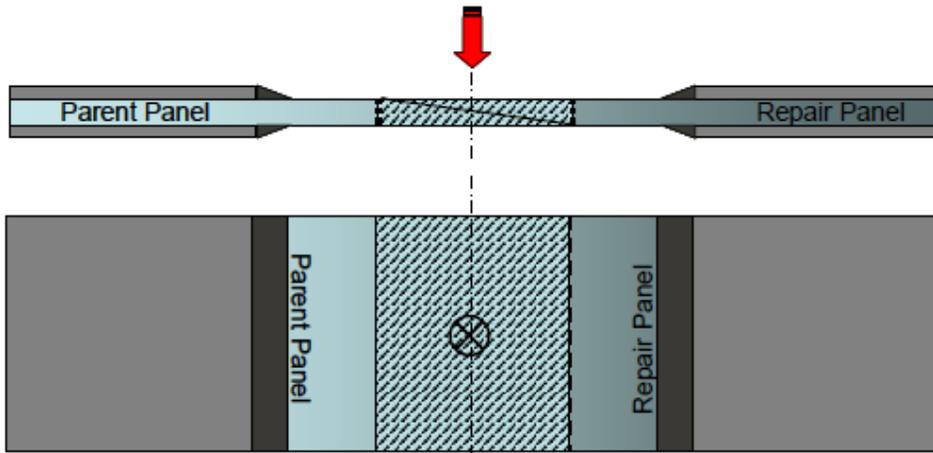
**Figure 26. Damage site for the impact specimens CN (center)**

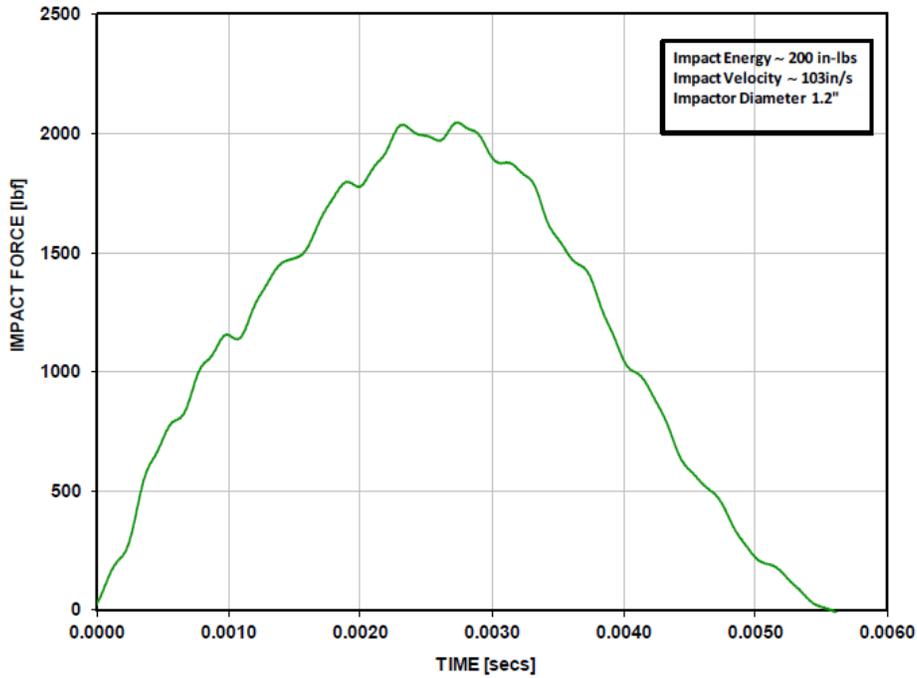
**Figure 27. Typical force time history for 18-E1-10-TF laminates**

Typical force time histories and force displacement curves for 18-ply and 48-ply specimens are shown in figures 27–36.

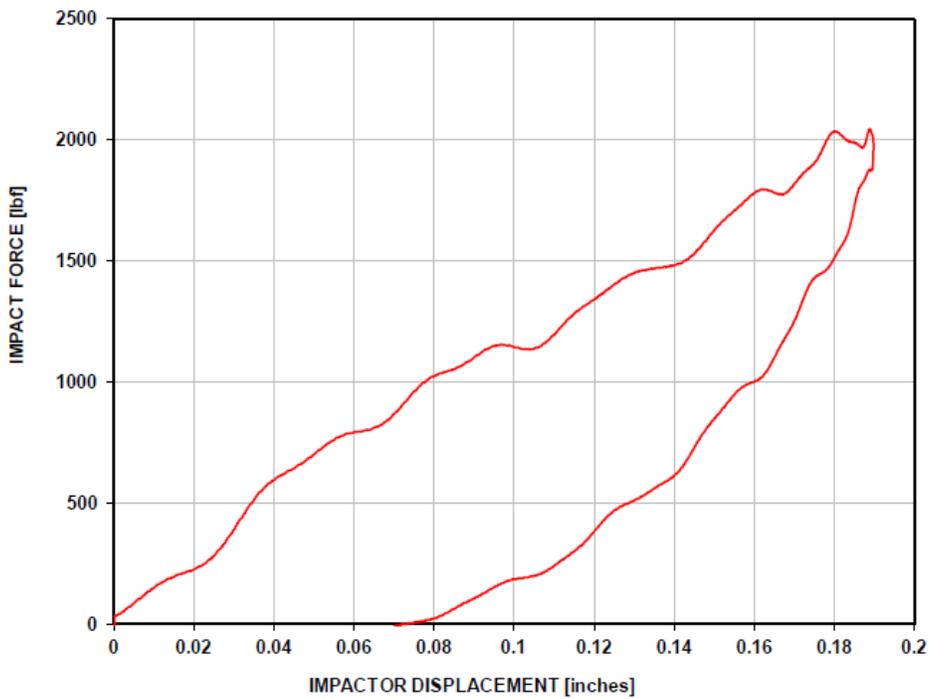
**Figure 28. Typical force displacement curve for 18-E1-10-TF laminates**

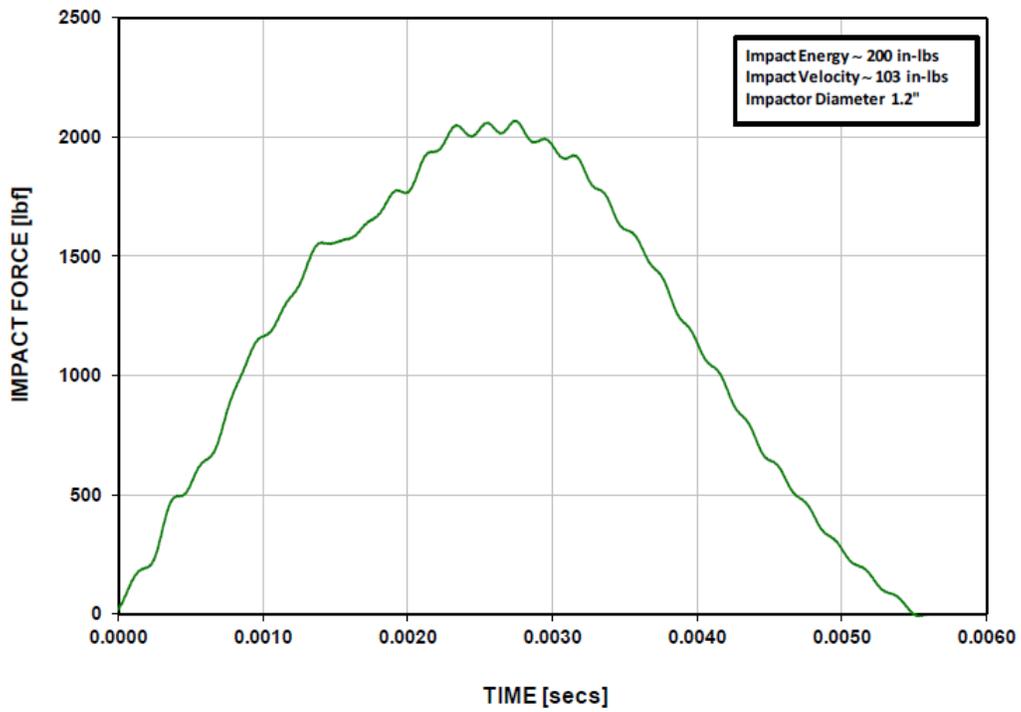
**Figure 29. Typical force time history for 18-E2-20-TF laminates**

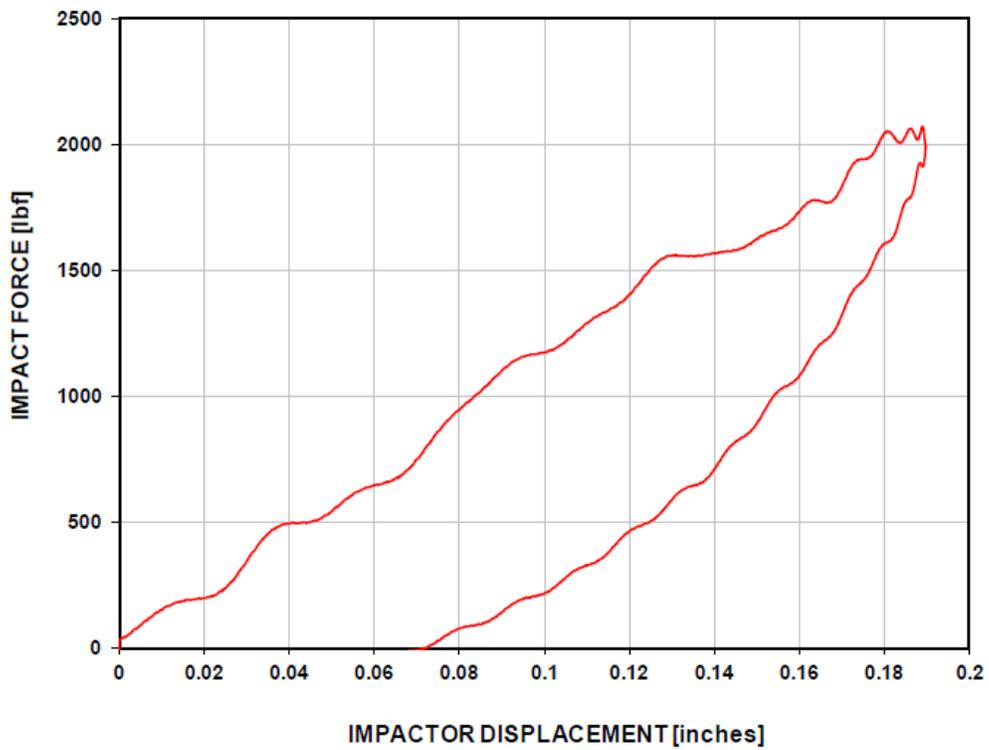
**Figure 30. Typical force displacement curve for 18-E2-20-TF laminates**

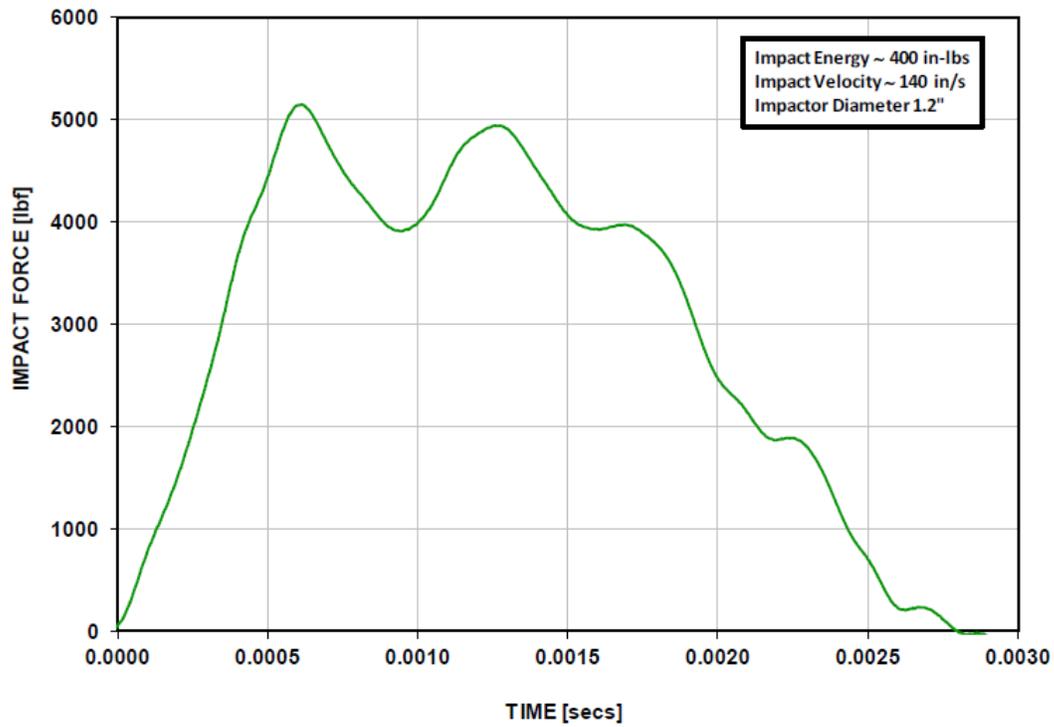
**Figure 31. Typical force time history for 48-E1-10-CN laminates**

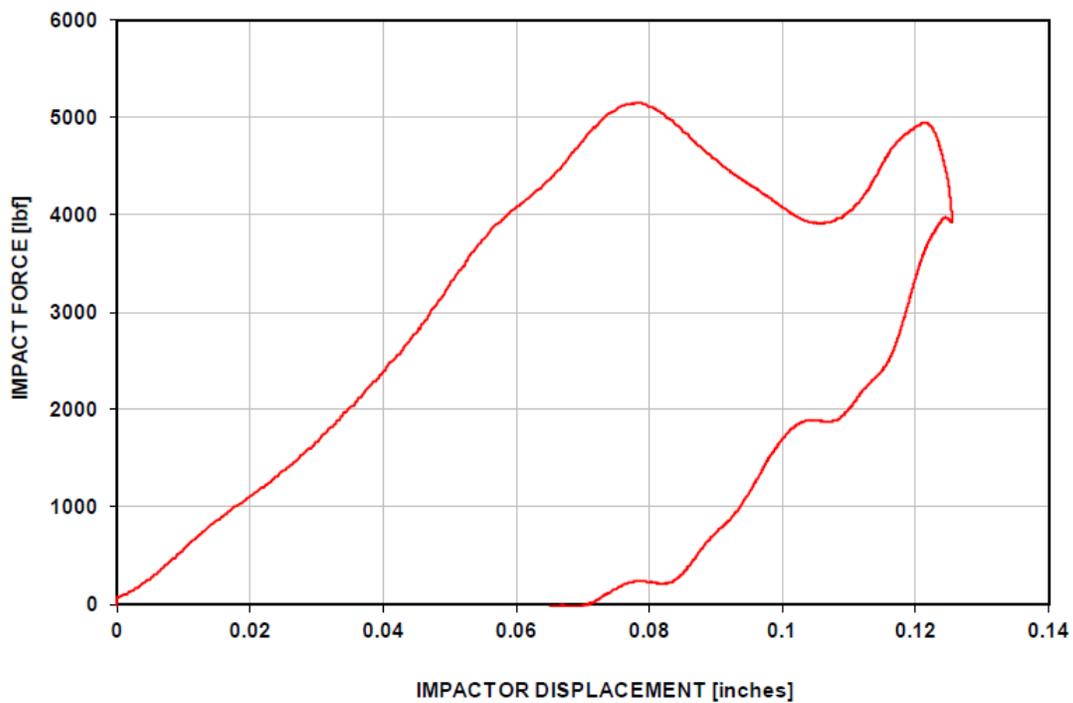
**Figure 32. Typical force displacement curve for 48-E1-10-CN laminates**

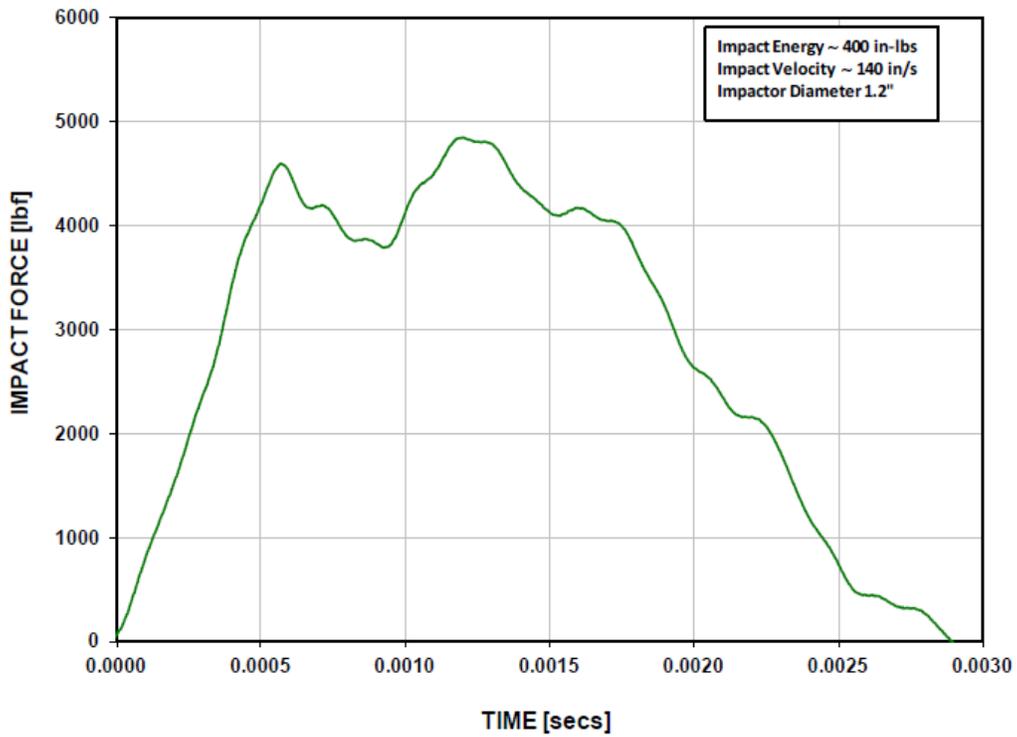
**Figure 33. Typical force time history for 48-E1-20-TF laminates**

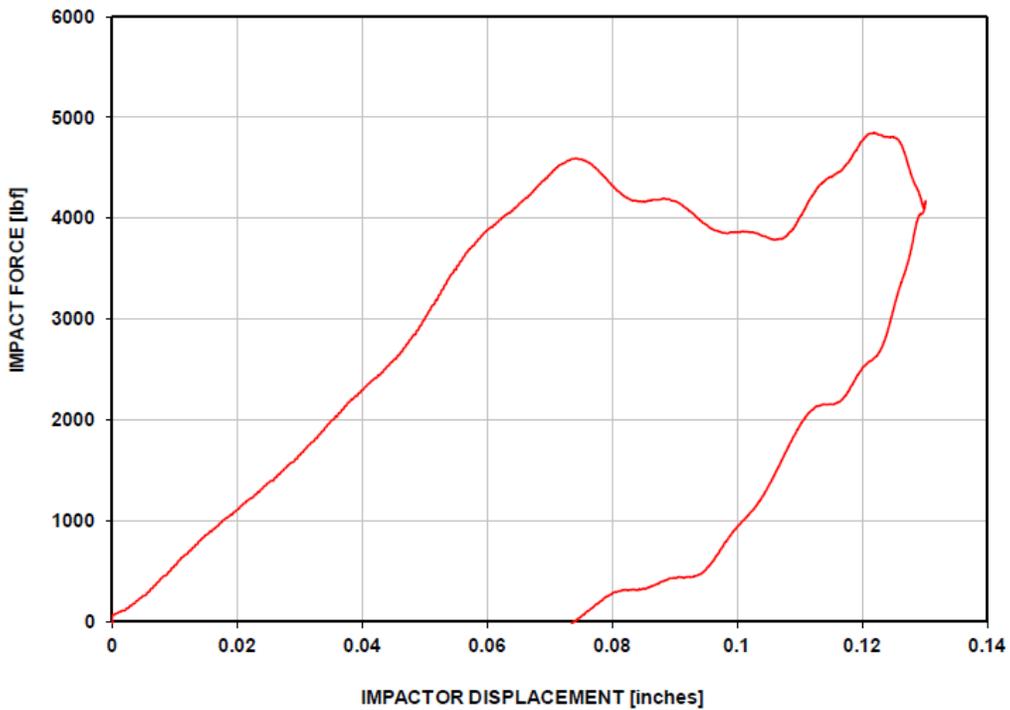
**Figure 34. Typical force displacement curve for 48-E1-20-TF laminates**

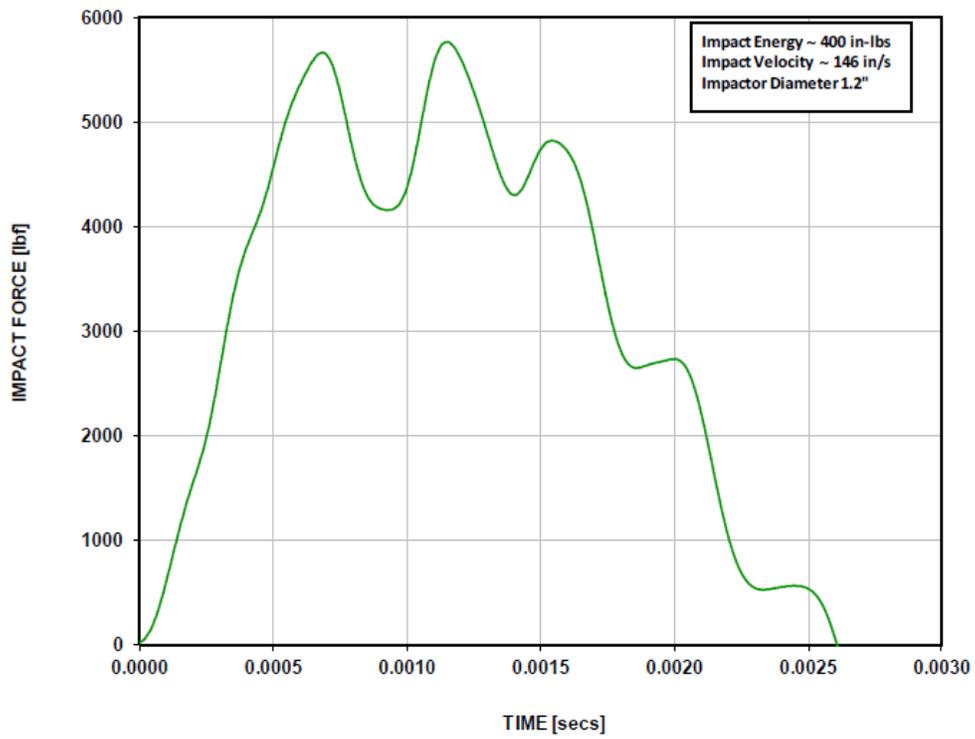
Figure 35. Typical force time history for 48-E2-20-TN laminates

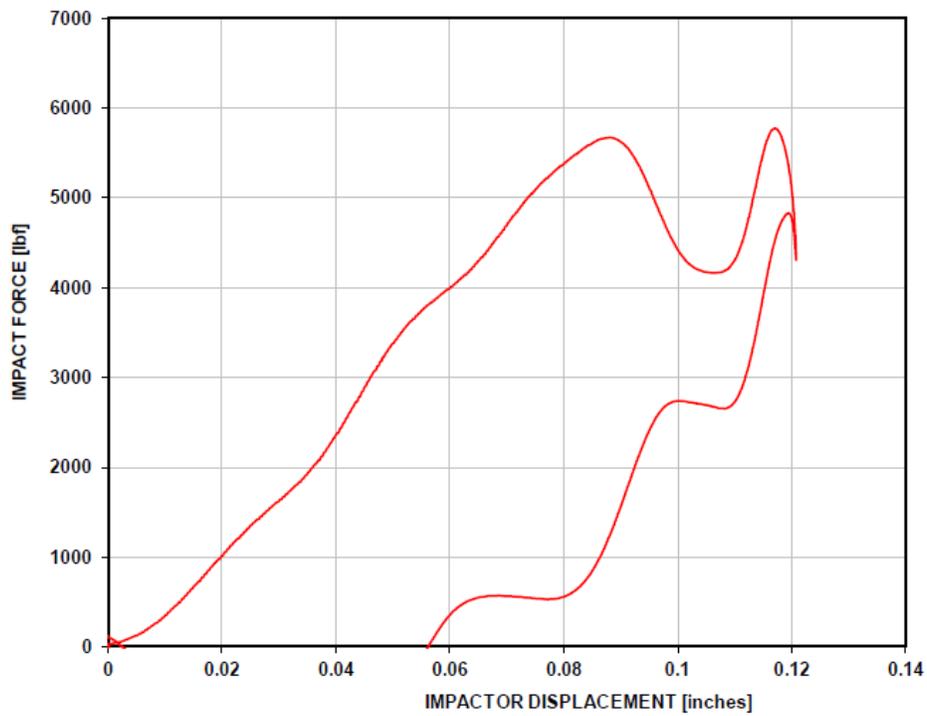
Figure 36. Typical force displacement curve for 48-E2-20-TF laminates

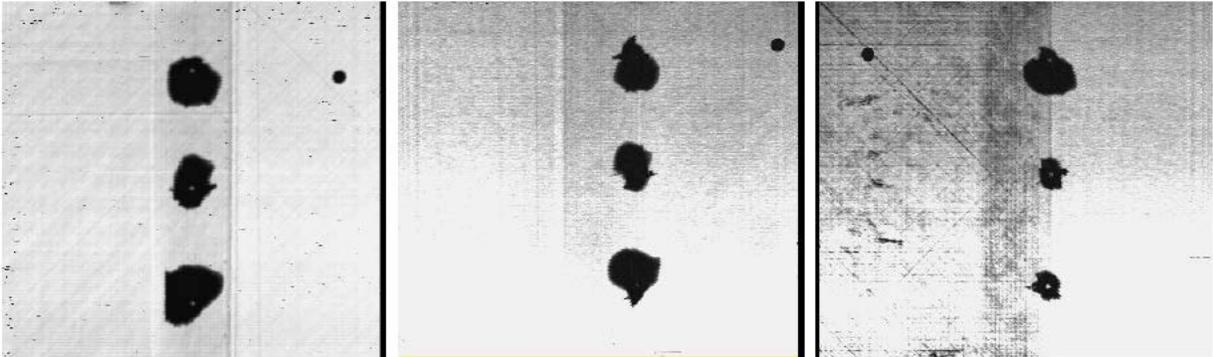
**Figure 37. C-Scans of 18-E1-20-CN-RTF/18-E1-20-TF-RTF/18-E1-20-TN-RTA panels**

Figures 37–40 show typical C-Scans of the repaired panels prior to machining them into individual specimens. It should be noted that the variability in the planar damage area resulted from varying impact sites.
